# Manhole Inspection Summary

Manhole # S4500\_018MH

Insp Date: **2/4/10 12:34 PM**

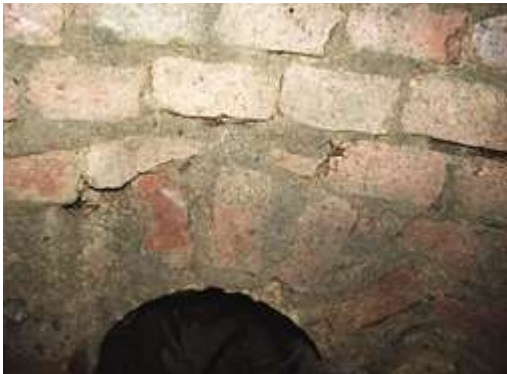
Defect 3

cracks

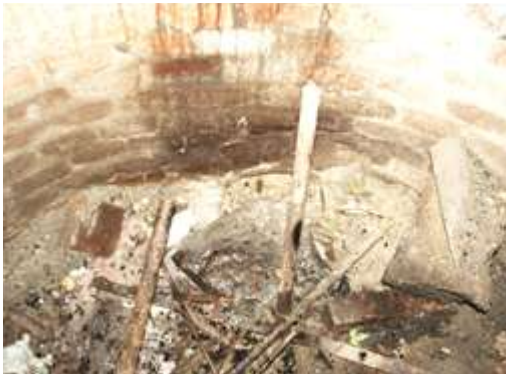
Defect 2

debris

Deposits: ☐ None ☐ Mud ☐ Sludge ☒ **Debris** ☐ Grease

Silt Depth: **4** (in.) Deposits Extent: **Heavy**

Silt Depth: **6** (in.) Deposits Extent: **Heavy**

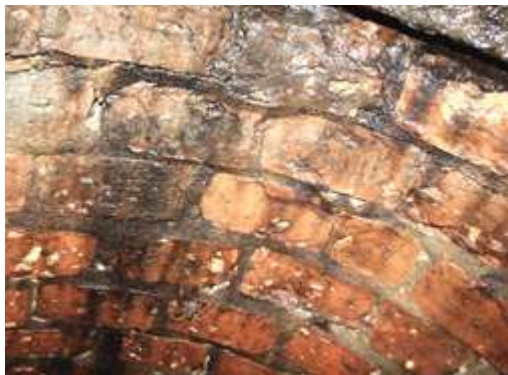
### Defect 1

Condition: ☐ Sound ☐ Cracked ☒ **Leaks**

Condition: ☐ Sound ☐ Cracked ☐ Root Intrusion ☐ Loose Brick ☒ **Deteriorated**

Infiltration: ☐ None ☒ **Joint** ☐ Cracks ☐ Mortar ☐ Roots ☐ Wall

infiltration
